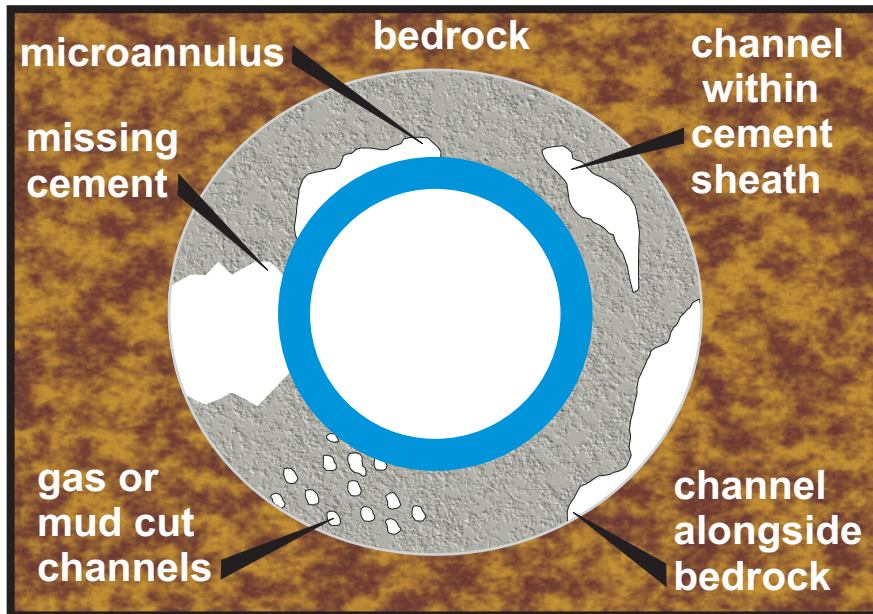
Types of cement channels in annular spaces that may permit upward methane migration. From Newhall (2006).

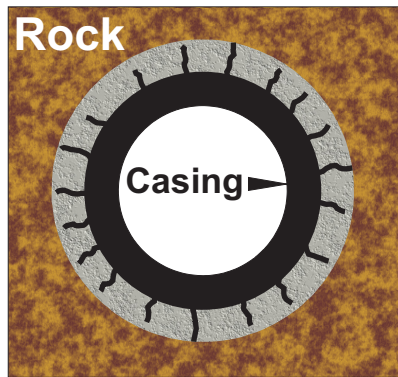
Cracks in cement sheath.

Figure 5. Well operations may lead to loss of zonal isolation resulting from failure of the cement sheath. Some failure mechanisms are depicted. From Ravi et al. (2002). HydroQuest
Graphic

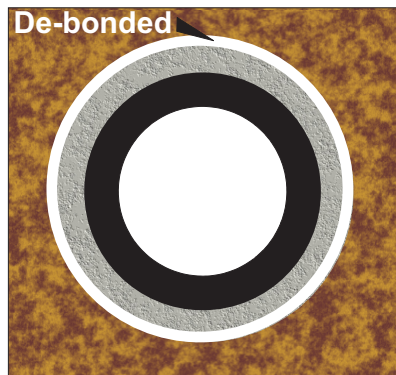
Debonding at rock/cement interface.

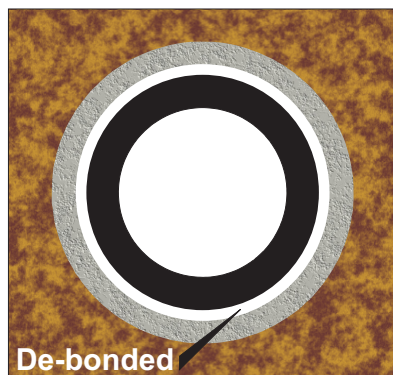
Debonding at cement/casing interface.
