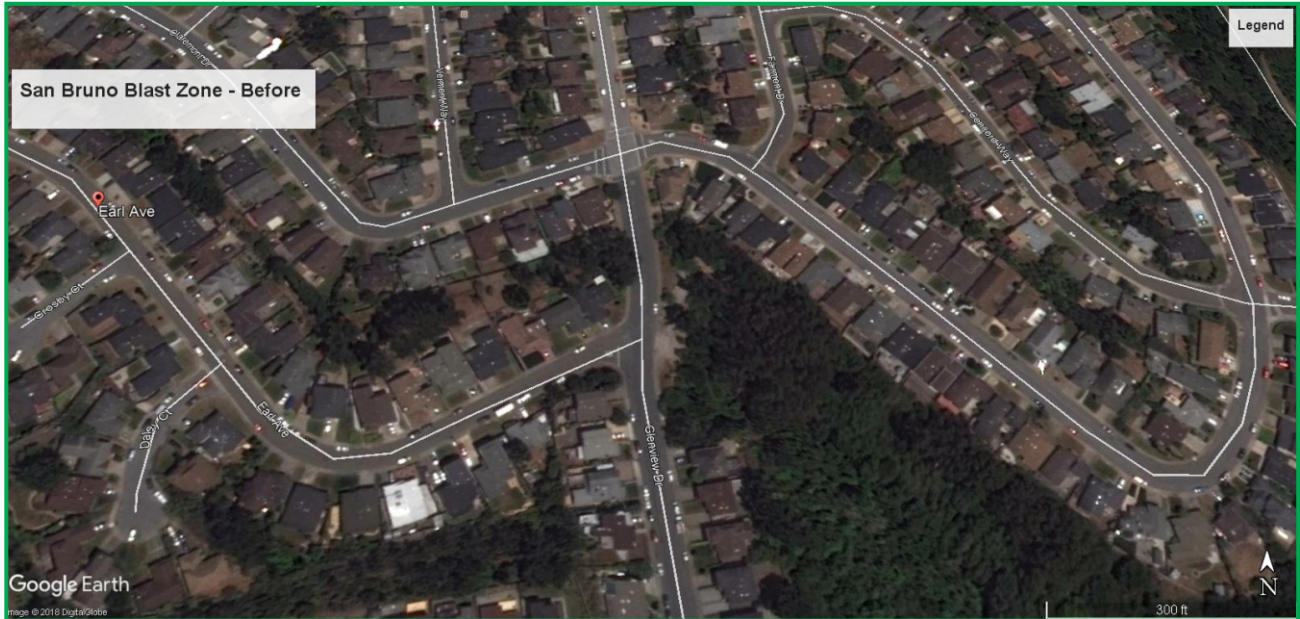
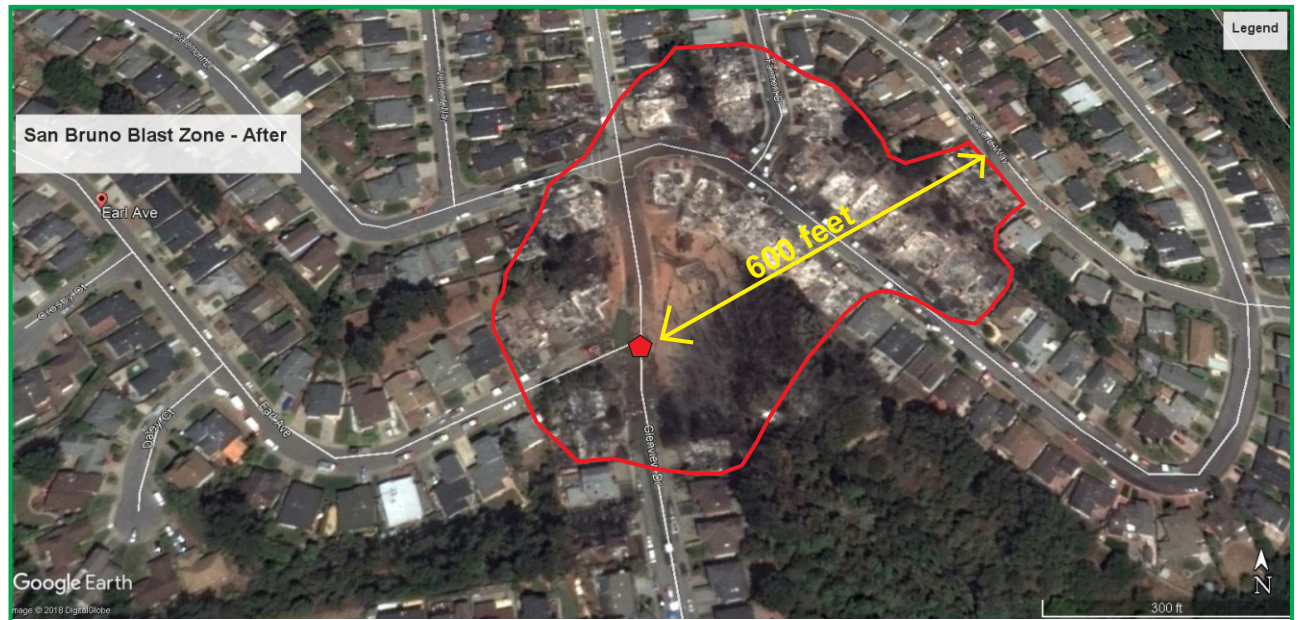
Red polygon: ~Blast zone with homes leveled on Sept. 9, 2010. Google Earth photos.

Google Earth areal photographs depict an intact housing development in July 2010 before the San Bruno pipe rupture (top) and after in September 2010. The failed pipeline had a 30-inch diameter and an operating pressure of 386 psi at the time of rupture. Many lives and homes were lost. The 42-inch Atlantic Sunrise Pipeline, if operational, would operate at 1,480 psi. **Figure E**
